SERVICE BULLETIN – 01/OCTOBER 2004

SD 18

NEW POSITION OF THE CLEANING SWITCH

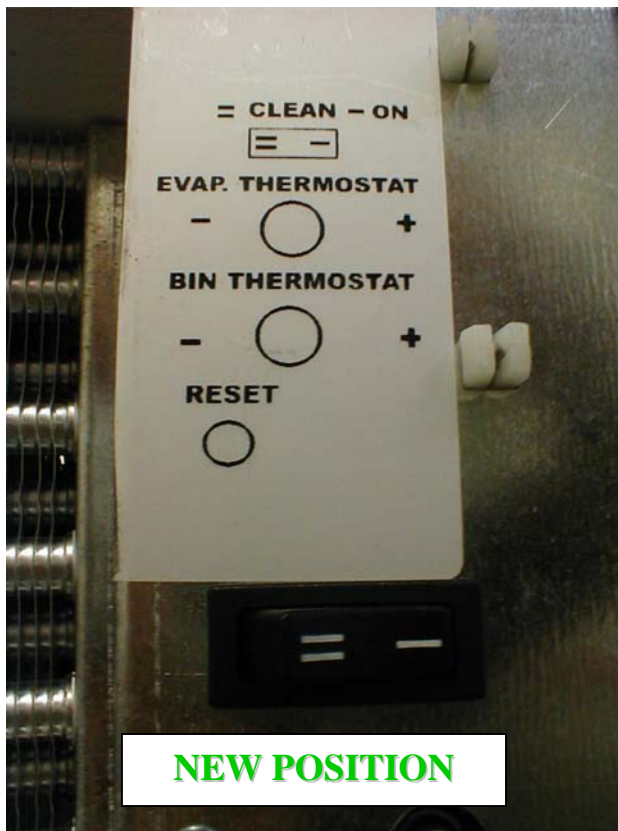
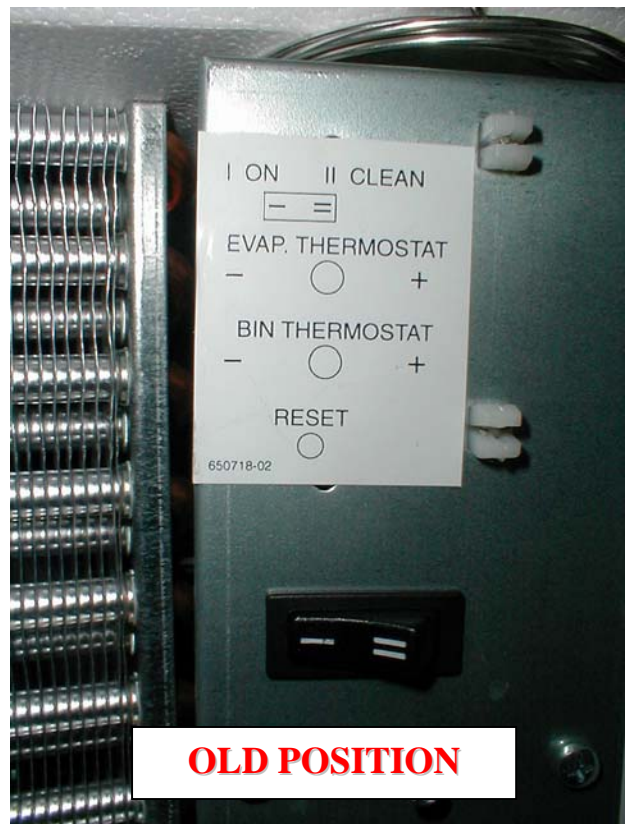
The Cleaning Switch has been rotated up side down as shown on photos below.

The new position of the Cleaning Switch avoids the wrong commutation to the cleaning position during the installation of the frontal panel.
